earthquake in Niigata: picture quiz

The following pictures were taken in Niigata just after the earthquake in October 2004. Look at each picture: can you work out what has happened? How would it have looked before the earthquake? Write a short description of what you see, then check the answers at the bottom of the page. (Pictures are courtesy of Niigata University) NB Larger copies of these pictures can be downloaded from japan21.org.uk

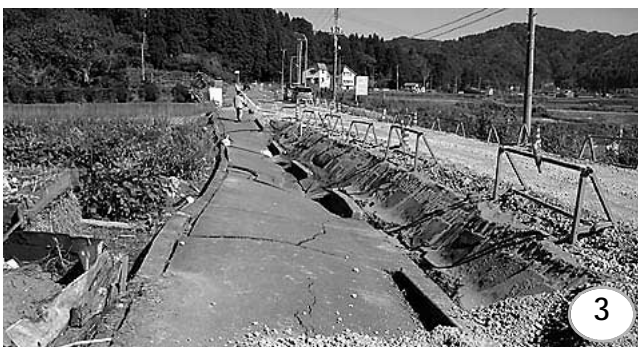
picture 3

Kashiwazaki city, Yasuda area, the road subsided along the water pipe.

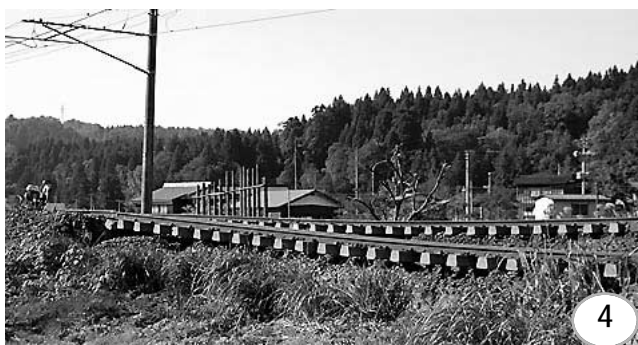
picture 4

Between Echigohirota and Nagatori, collapse of rail banking on the Shinetsu line.
